IRON BUCK INSPECTIONS

## RESIDENTIAL HOME INSPECTION

123 N 456 W  
Layton, UT 84041

John Doe  
08/19/2025

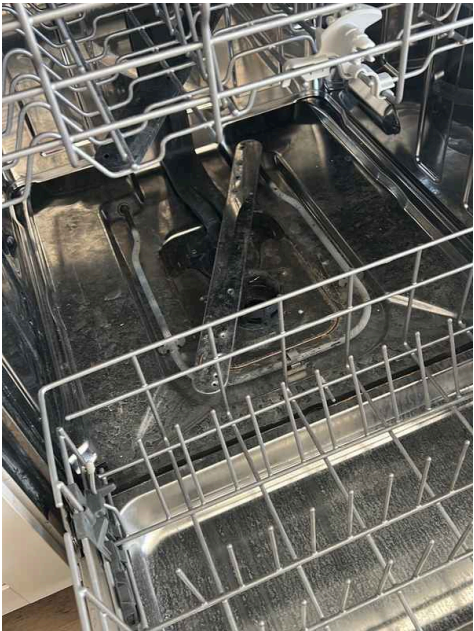
Observation: Hard water scaling was observed in the dishwasher at the time of the inspection.

Why It Matters: Hard water scaling can build up over time, affecting the dishwasher’s performance by reducing water flow and potentially damaging components. It may also leave stains on dishes and reduce cleaning efficiency.

Recommendation: Recommend cleaning the hard water scaling in the dishwasher to restore its efficiency and prevent further buildup. Regular maintenance can help avoid long-term damage to the appliance.

Recommended DIY Project

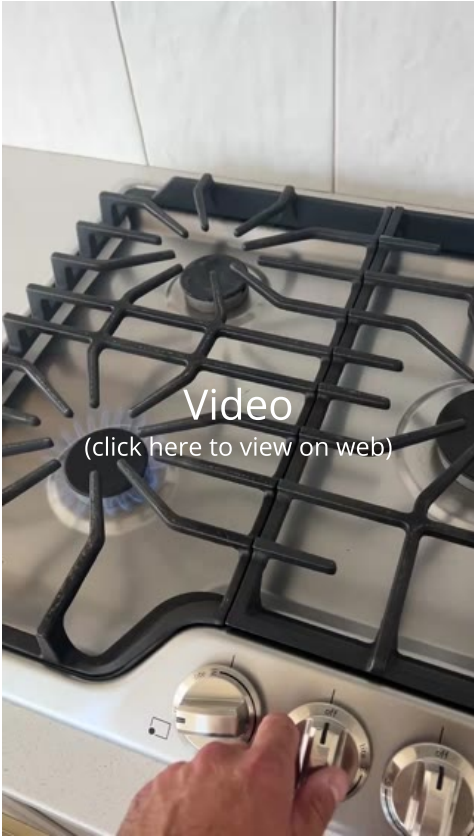
2.3.1 Range

**GAS BURNER NOT LIGHTING**

Observation: One of the gas burners on the range did not light or function during the inspection.

Why It Matters: A malfunctioning gas burner can hinder cooking performance and may indicate an issue with the ignition system, gas supply, or burner components.

Recommendation: Recommend further evaluation and repair of the gas burner by a qualified technician to ensure proper operation and safety.

Contact a qualified handyman.

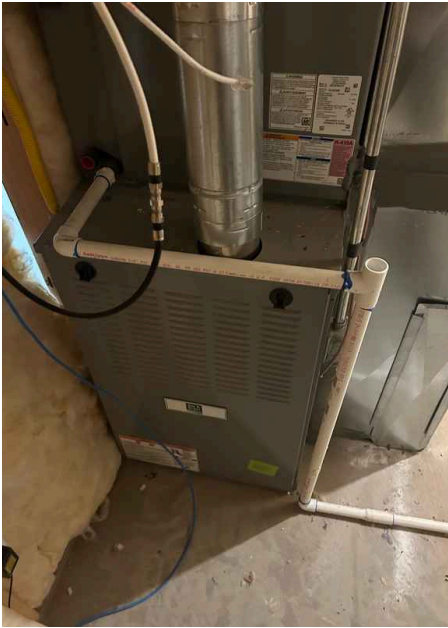
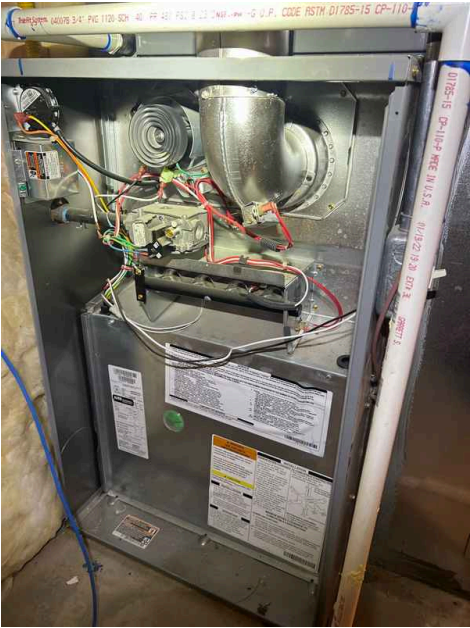
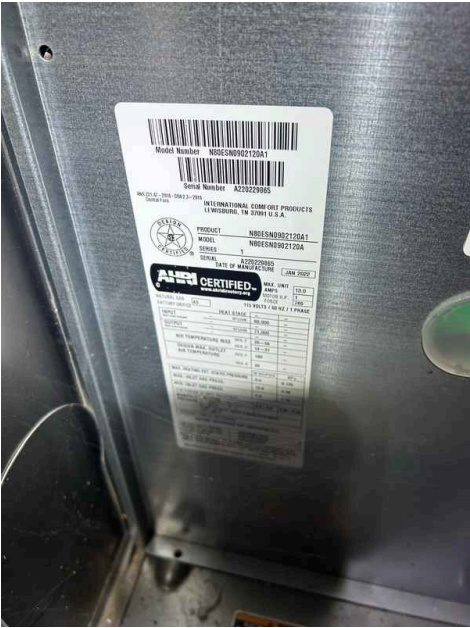
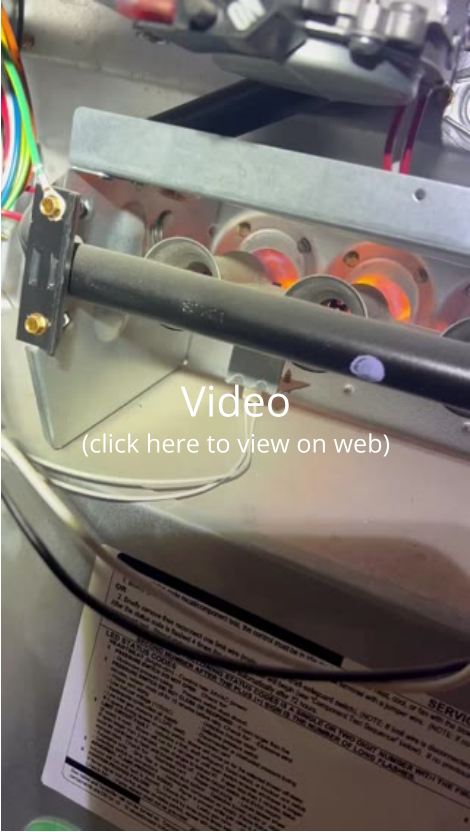
Heating System: Heating Method and Energy Source  
Gas, Forced Air

I looked at the heating system and the service switch/emergency disconnect.

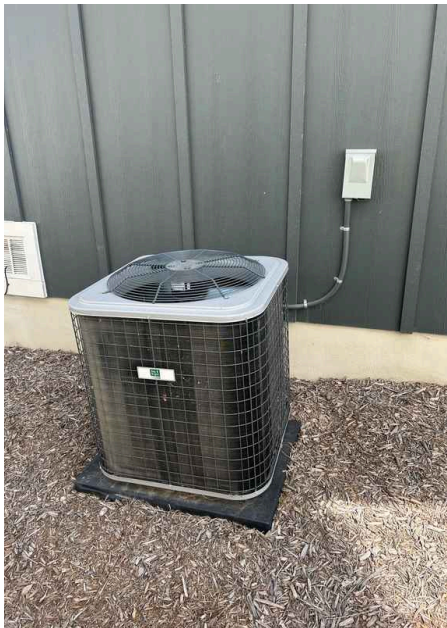
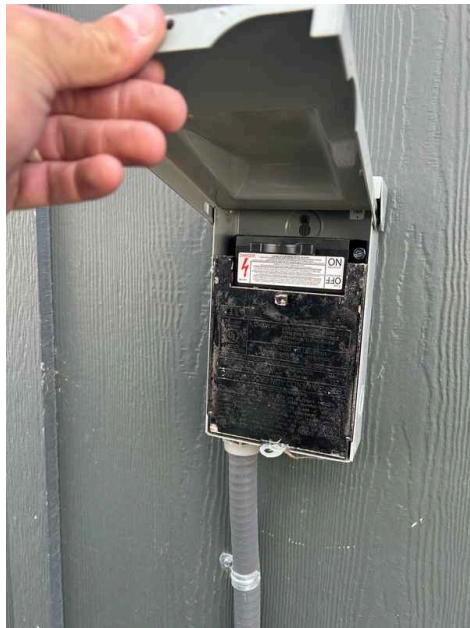
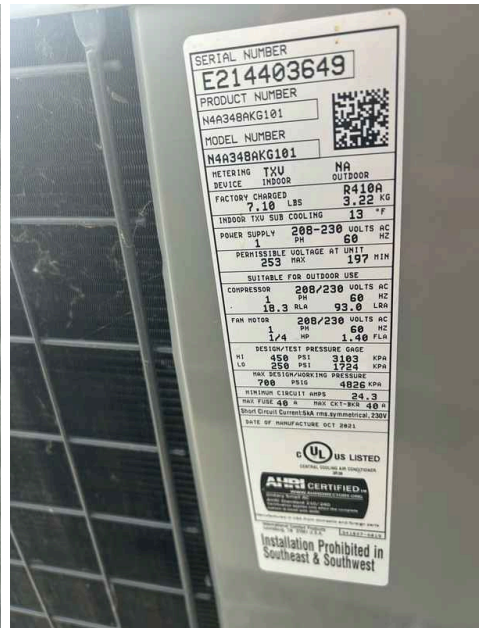
## Cooling System: Air Conditioning Condenser

I looked at the condenser during the inspection

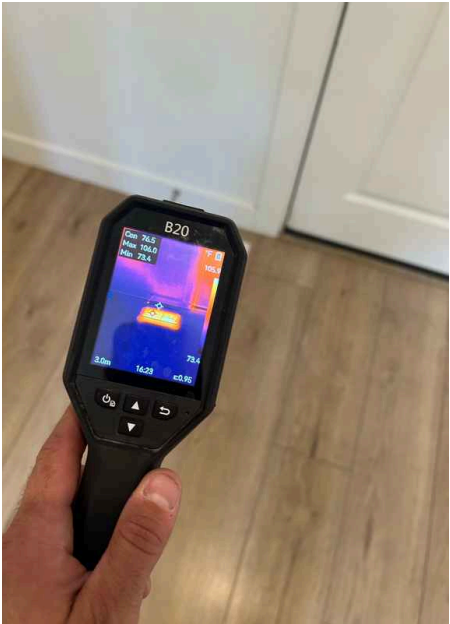
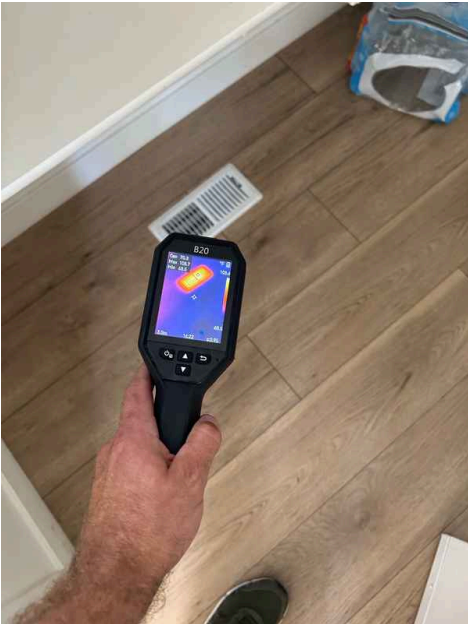
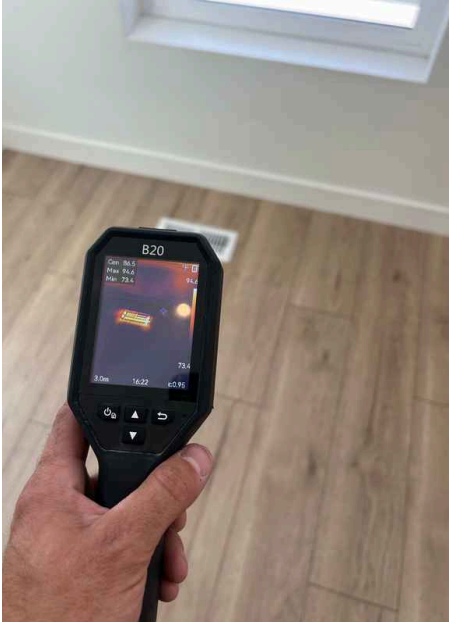
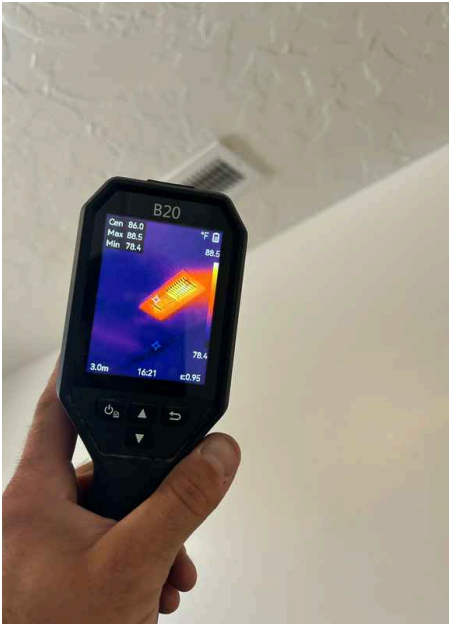
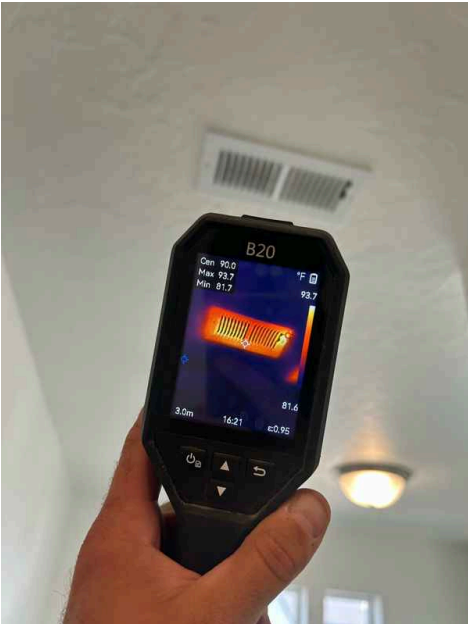
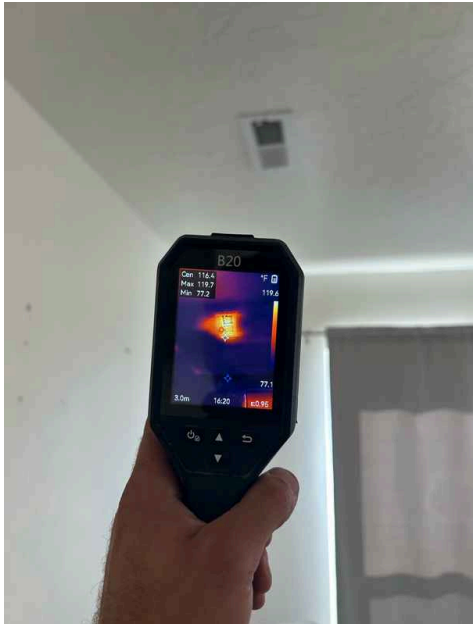
Registers: Registers

I checked a representative number of registers.

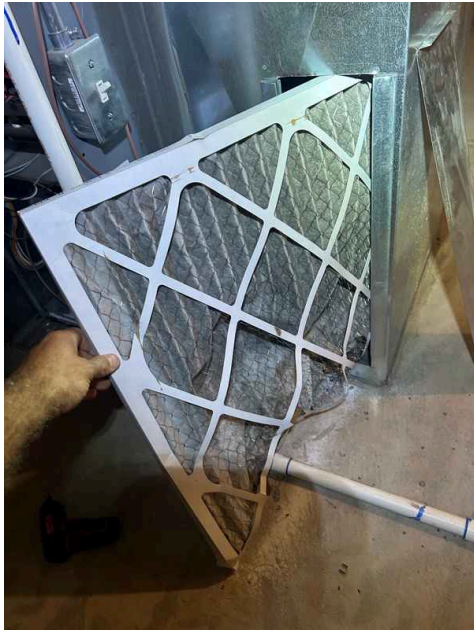
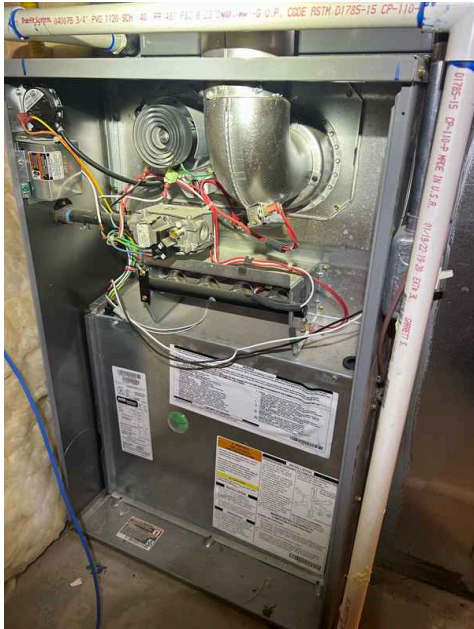
Observation: I observed indications of delayed maintenance at the heating system.

Contact a qualified heating and cooling contractor

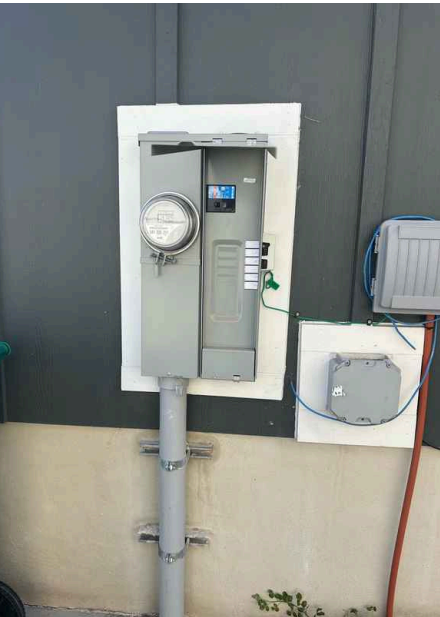
Side Of House, Square D

I looked at the panel where the main disconnect is located.

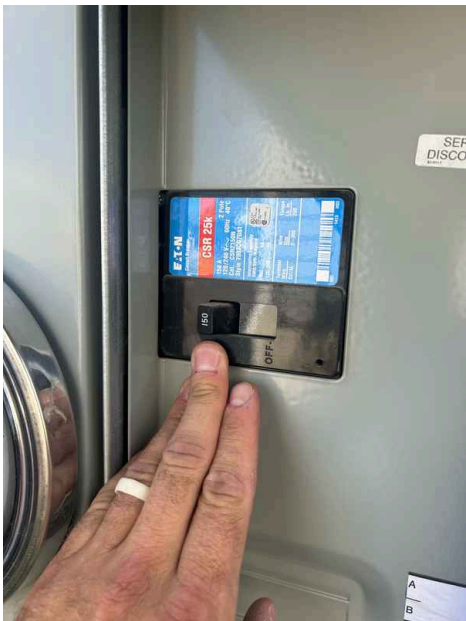
### Main Panel: Main Disconnect

Rating

150amp

I looked at the main disconnect, located in the main panel outside.

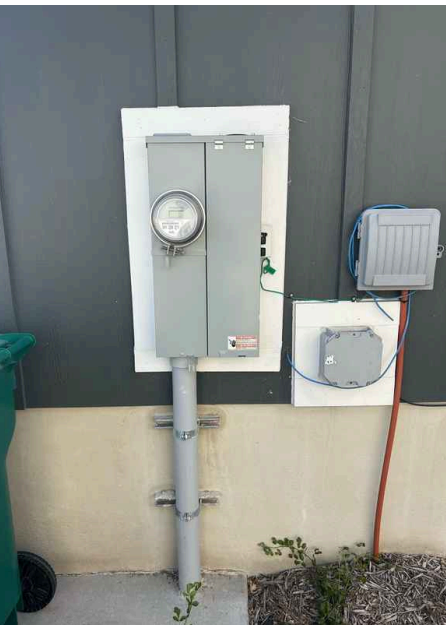
### Electrical Service Entrance: Electrical Service Entrance

While many components of the service entrance system were not accessible for inspection, I examined the visible parts where possible. These included, when present, overhead service entrance cables, service conduits, raceways, service heads, goosenecks, drip loops, service masts, and service entrance conductors to evaluate their condition and verify proper installation during the inspection.

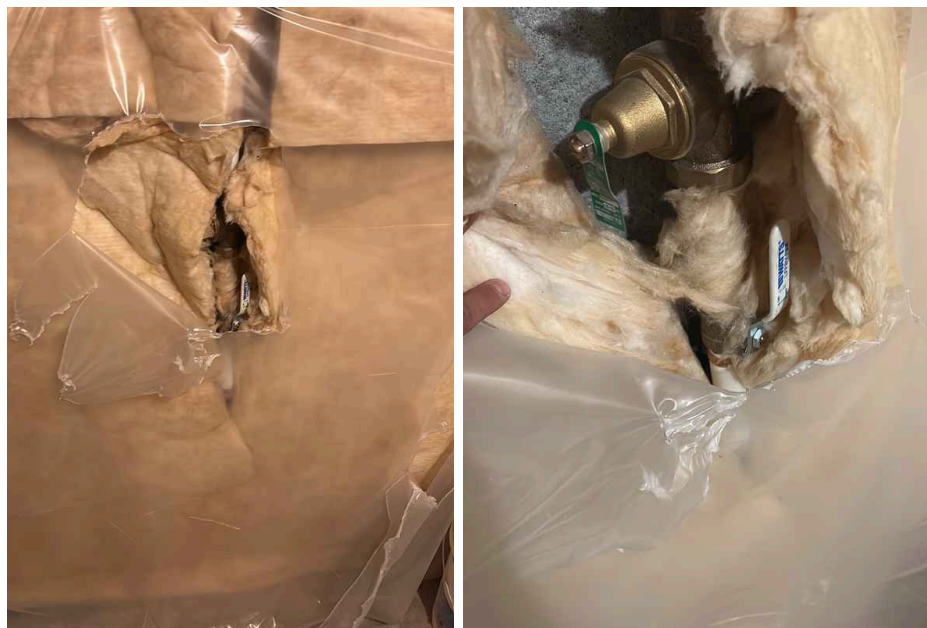
## Main Water Shut-Off Valve: Location of Main Shut-Off Valve

Basement

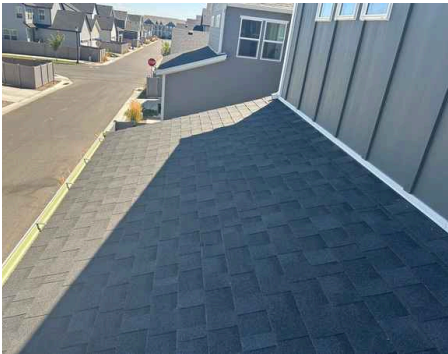
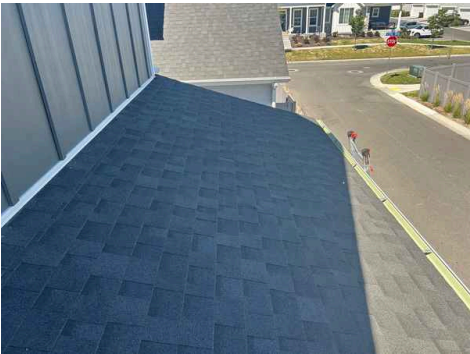
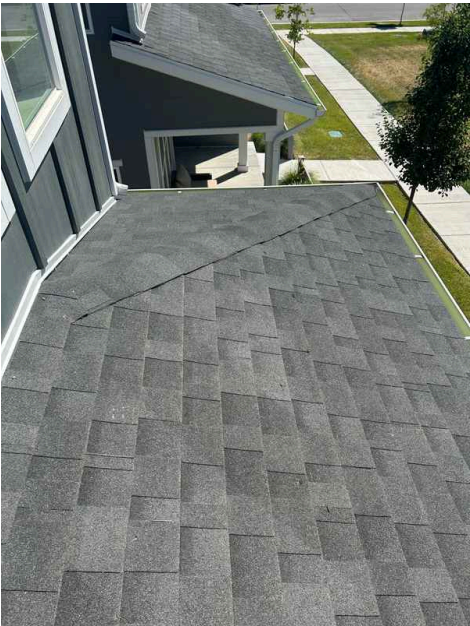
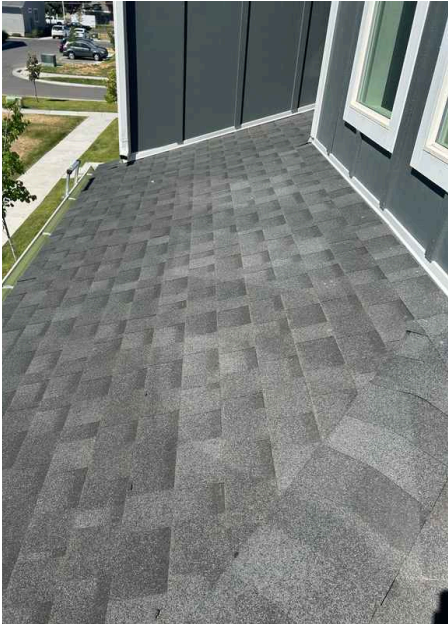
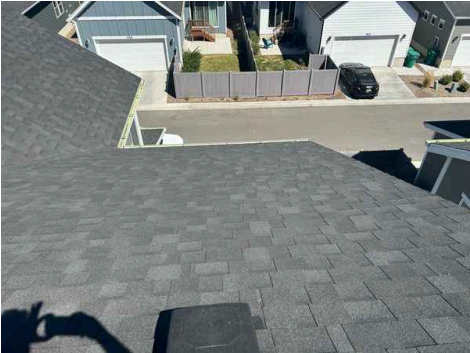
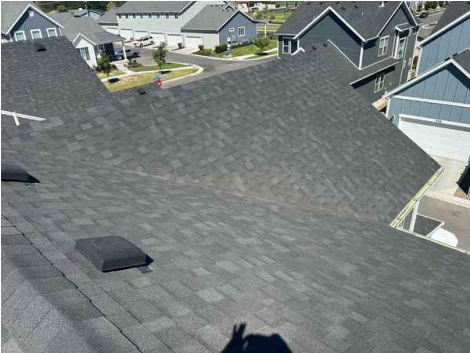
Roof Structure and Covering: Roof Structure (Exterior)

I looked at the roof's structure from the ground level and the roof to see if any ridge or sheathing issues stood out at the time of the inspection.

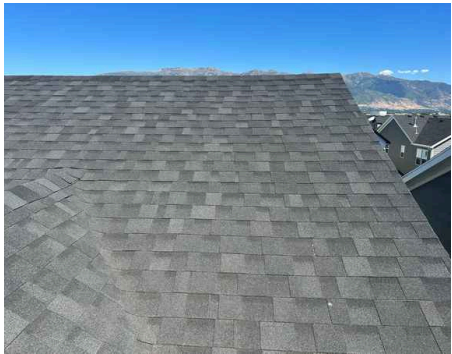
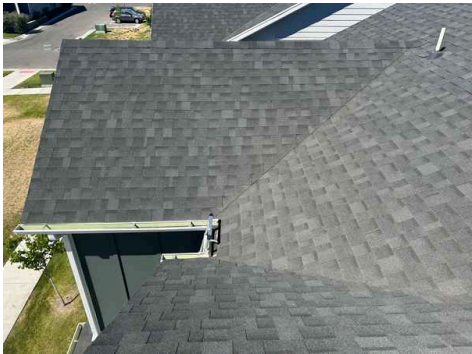
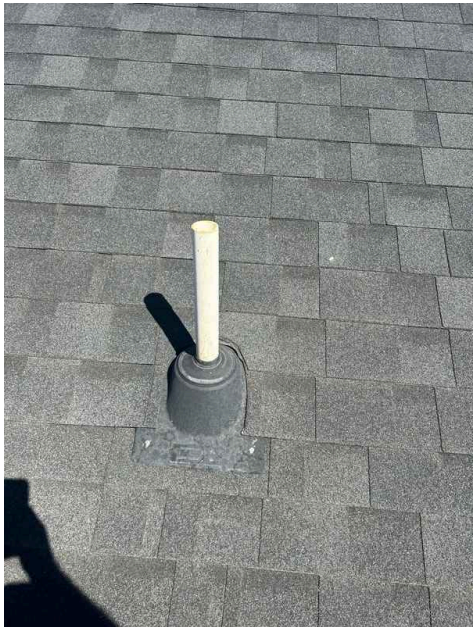
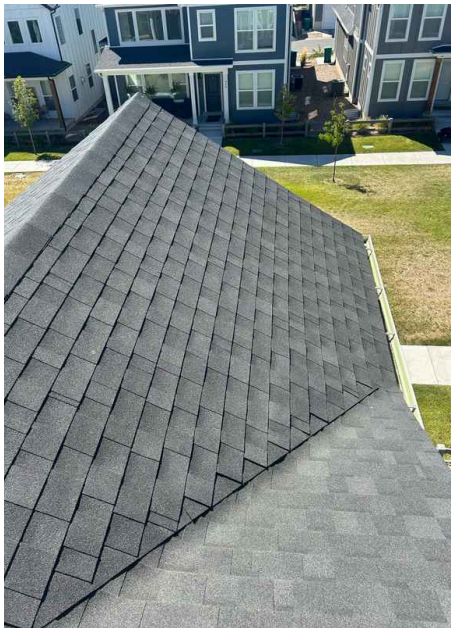
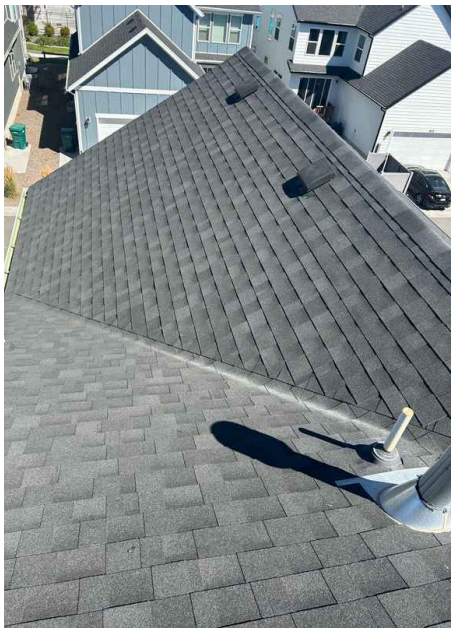
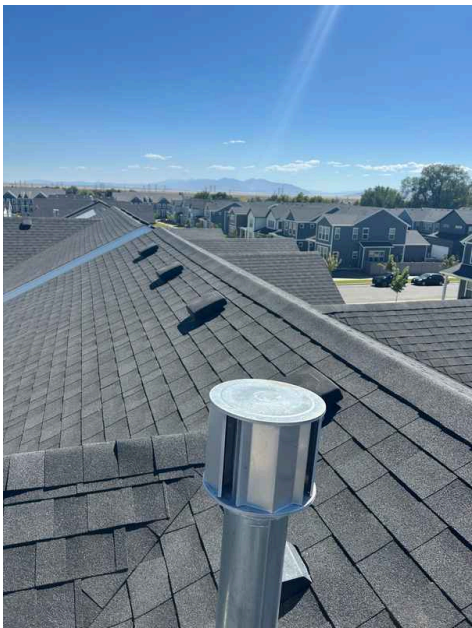
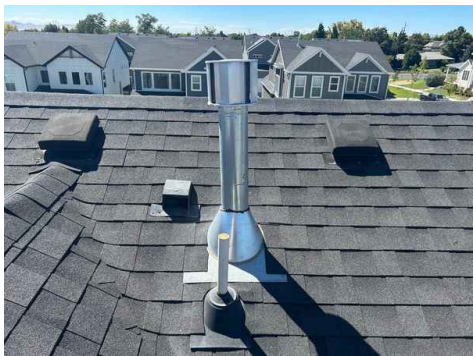
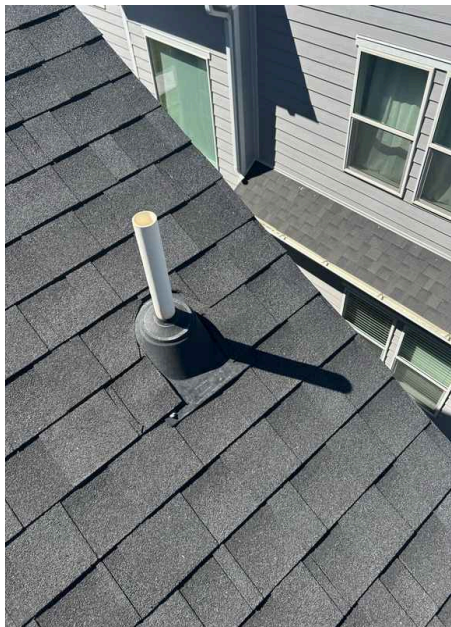
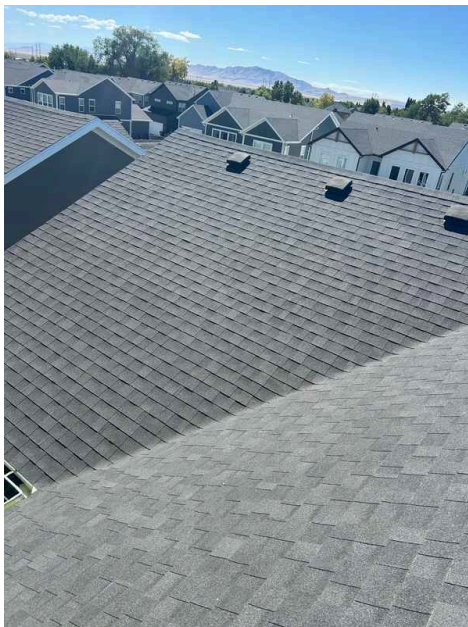
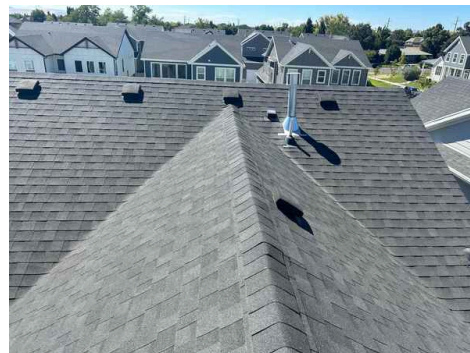
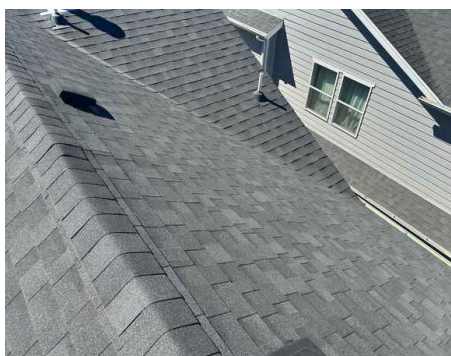
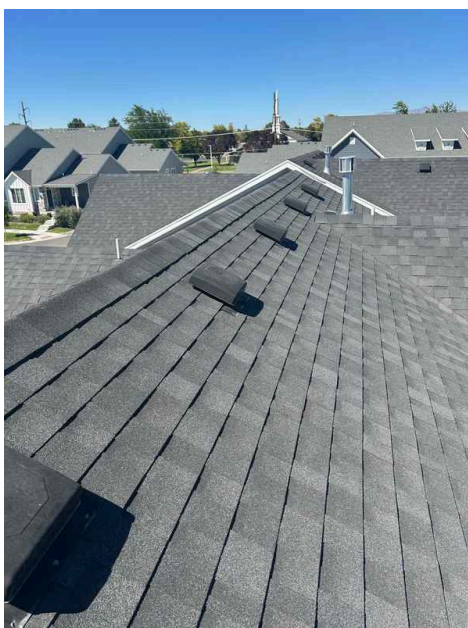
Observation: There were exposed fasteners at the roof, gutters discharging from an upper roof surface onto a lower surface, and several shingles with damage likely caused during installation or packaging.

Why it matters: Exposed fasteners can loosen and allow water intrusion, gutters draining onto lower roof surfaces increase wear in those areas, and damaged shingles reduce the roof's ability to shed water effectively.

Recommendation: Have a qualified roofing contractor evaluate the conditions and perform necessary repairs or adjustments to help maintain roof performance.

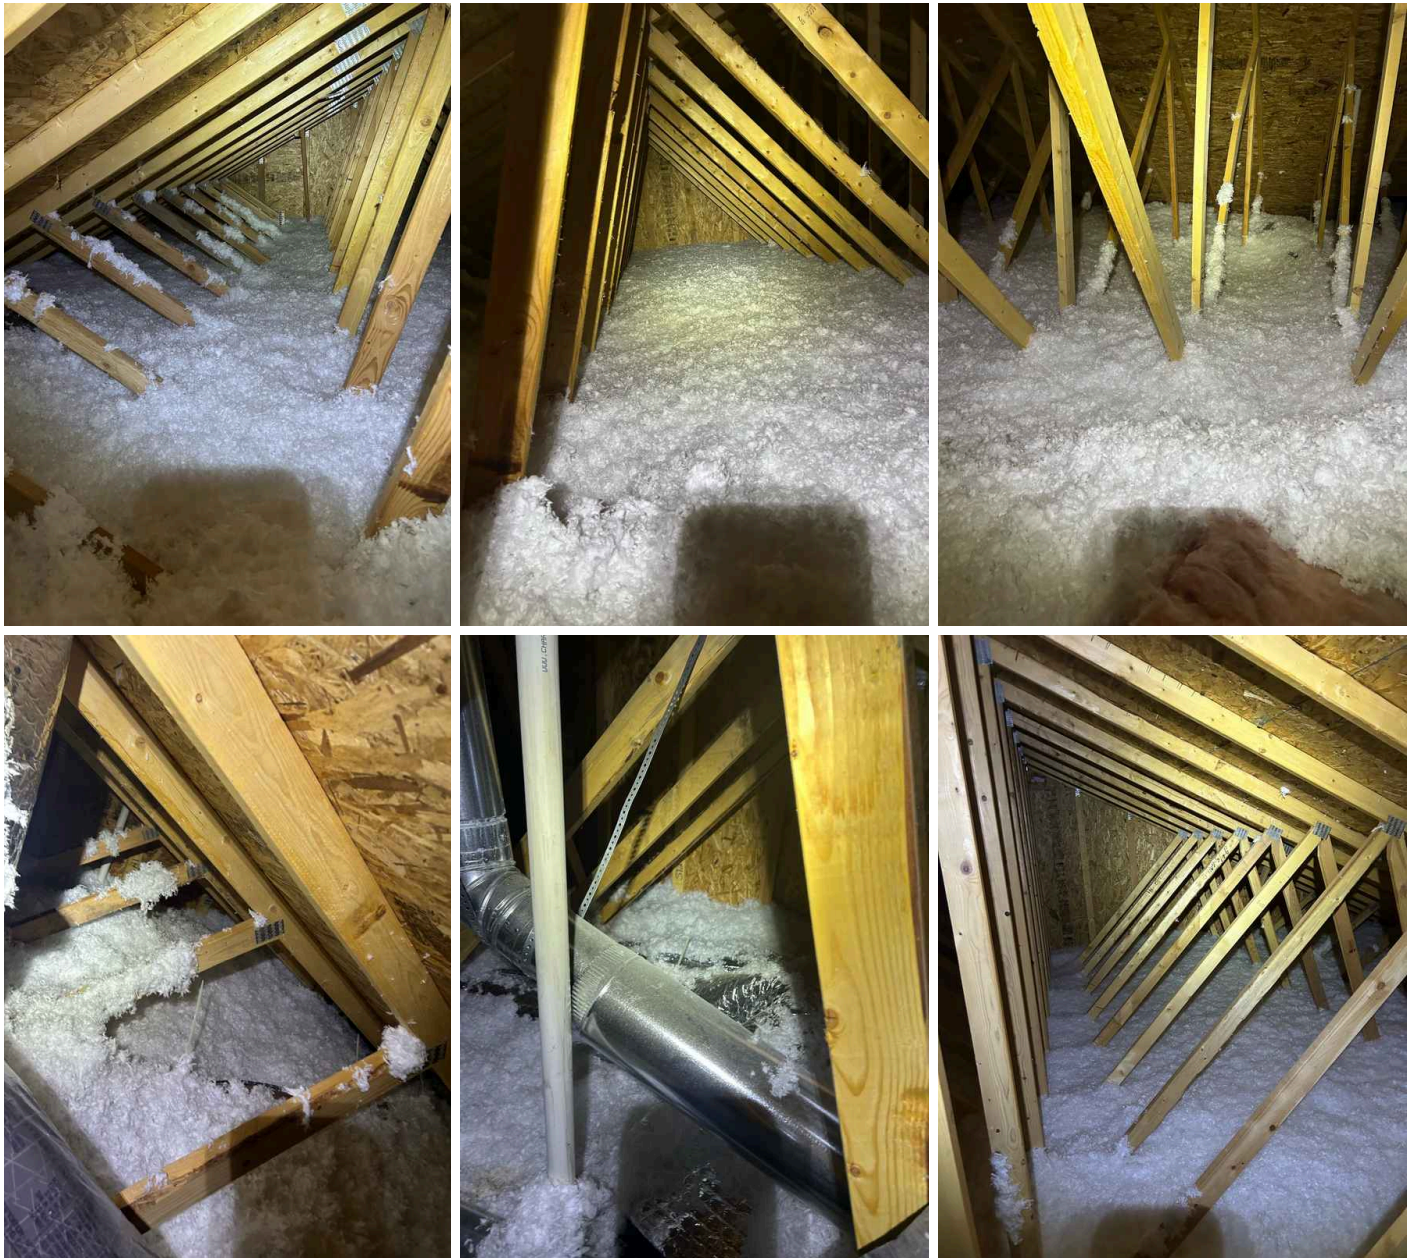
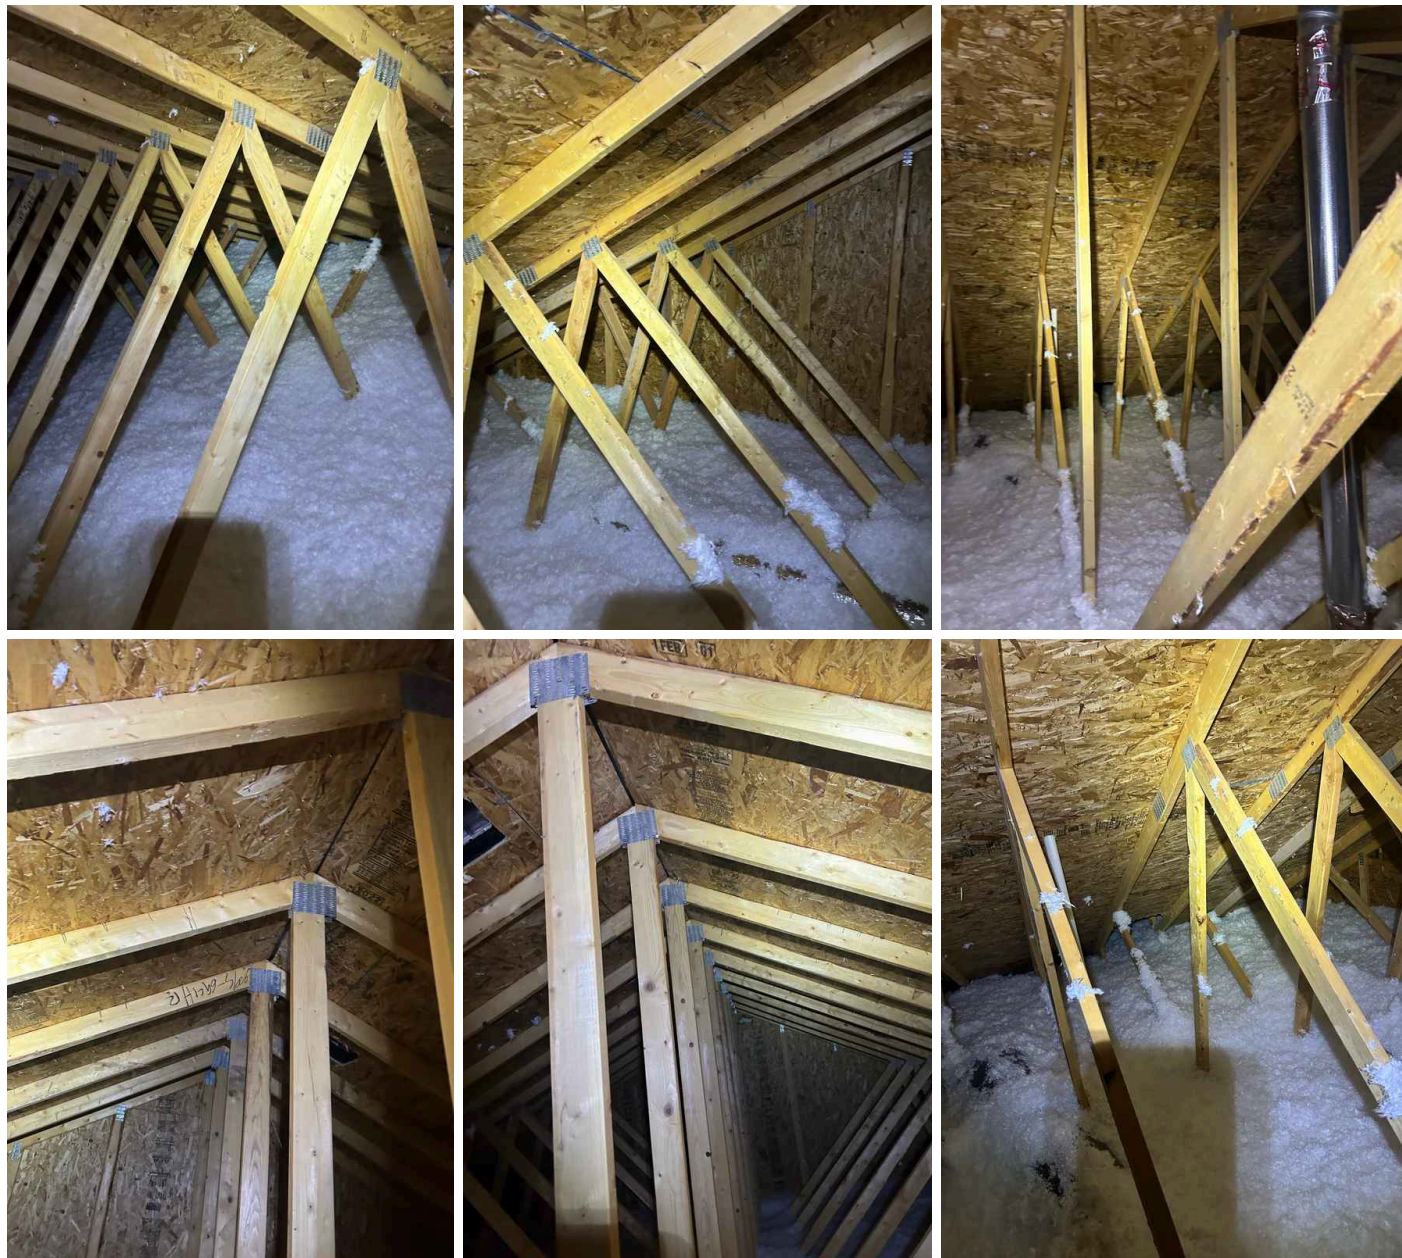
## Roof Structure: Roof Structure From Attic

The structural components of the roof were inspected from the attic space according to the [Home Inspection Standards of Practice](#).

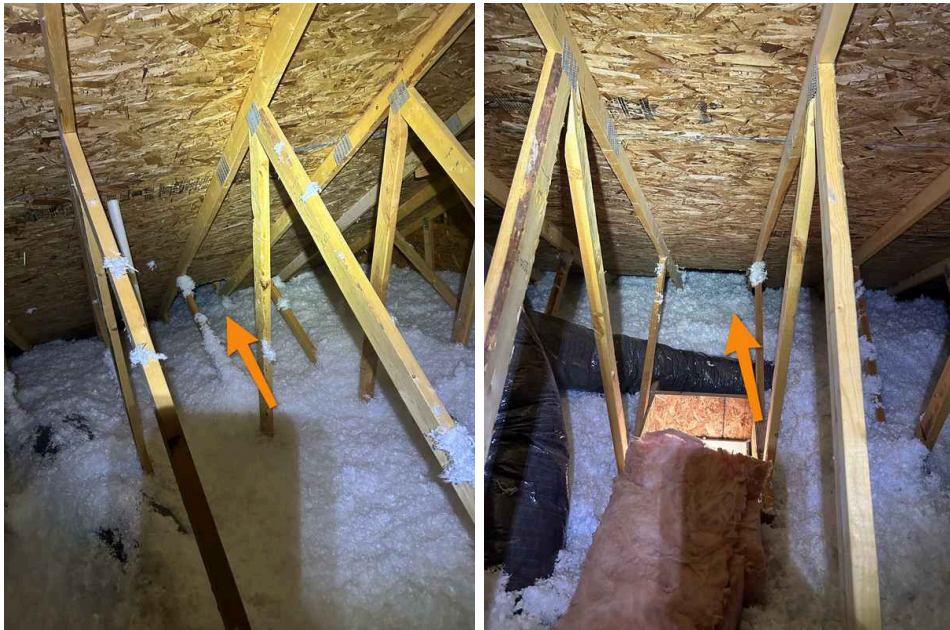
**INACCESSIBLE ATTIC SPACE**

I could not access all corners of the attic space at the time of inspection. I did my best, but access was limited based on the layout and framing. This was an inspection limitation.

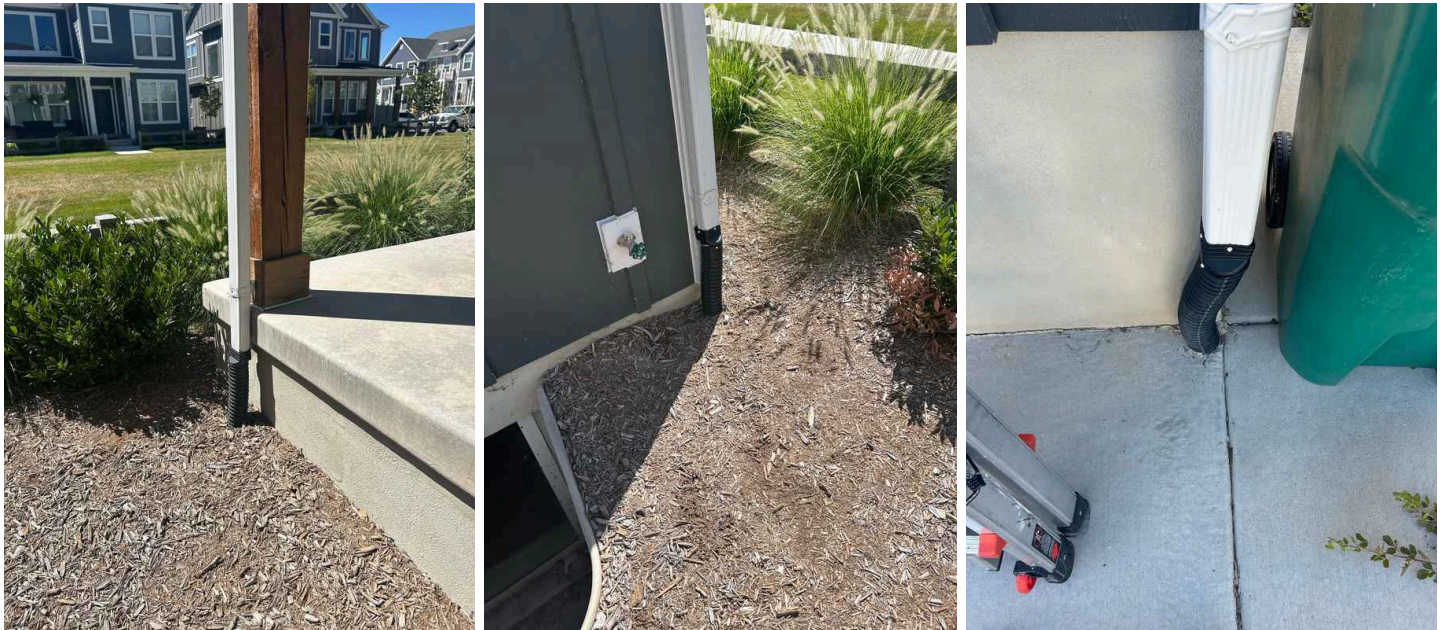
One or more downspouts were observed to discharge directly into the ground at the time of the inspection. Underground diverter drainage pipes cannot be inspected during a visual-only home inspection, so I cannot confirm the specific path or destination of the drainage.

Since these systems are not visible, further evaluation may be necessary if concerns about drainage exist.

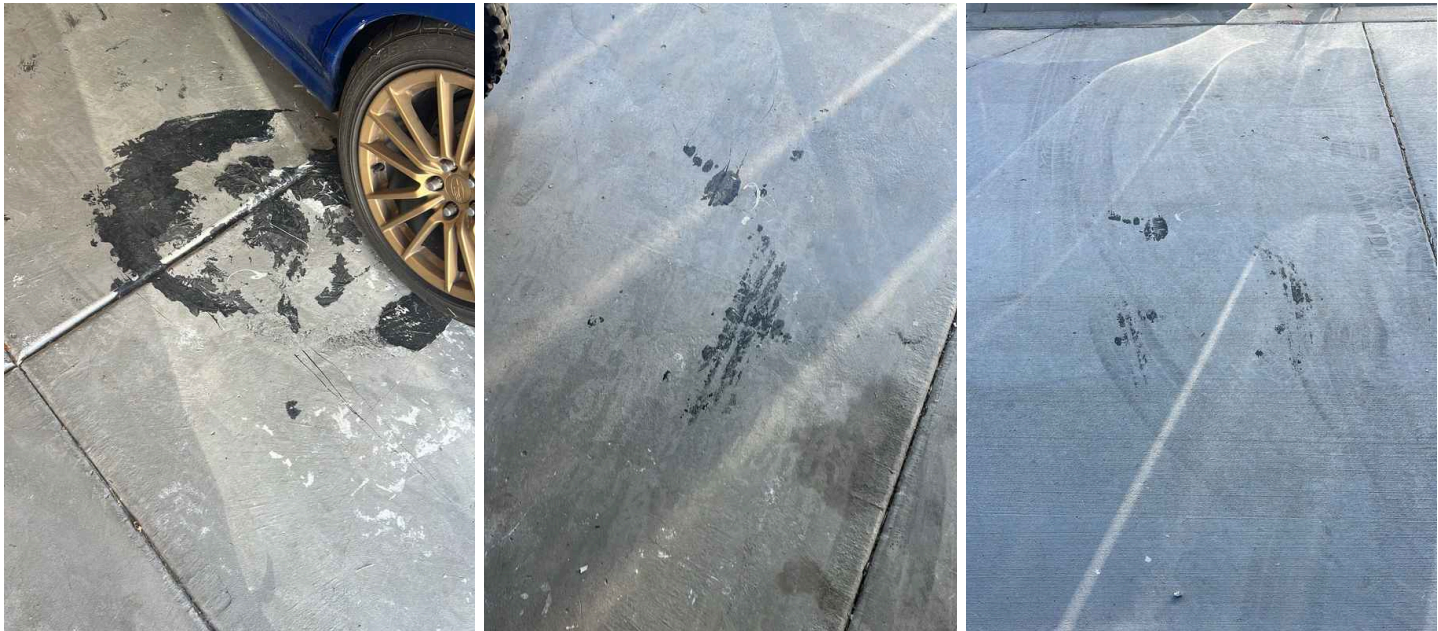
### 8.1.1 Paved Surfaces

Why it matters: Foreign substances on concrete can be cosmetic or may indicate chemical residue, staining, or previous repairs. They can make cleaning and maintenance more difficult and may affect surface durability over time.

Contact a qualified concrete contractor.

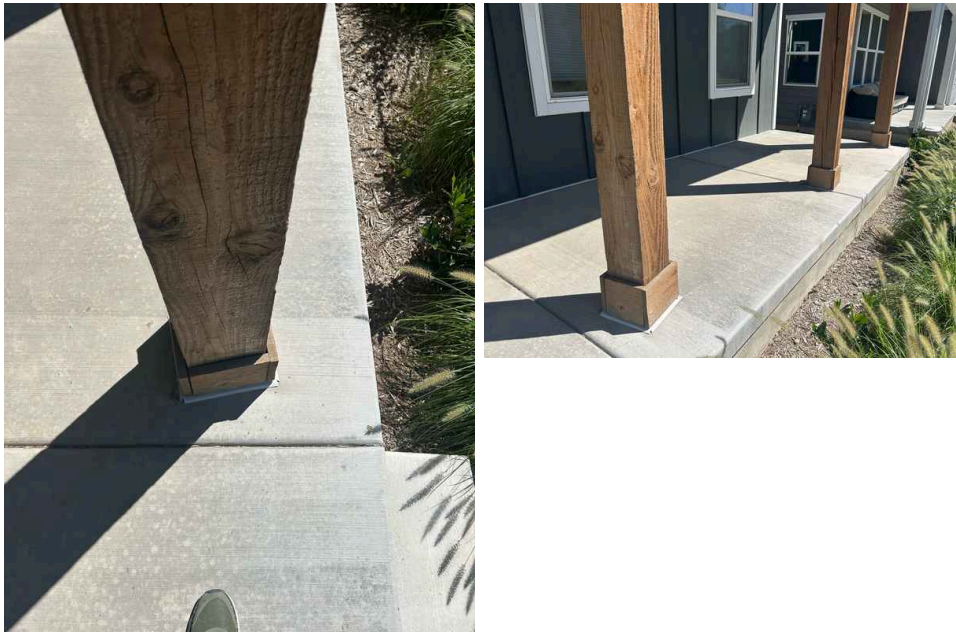
8.6.1 Porches, Decks & Balconies

WOOD IMPERFECTIONS AT FRONT PILLARS

Why it matters: Beam movement and twisting can affect the alignment of connected components, impact the home's appearance, and may progress over time with weather exposure.

Recommendation: Have a qualified contractor further assess the beam and pillars to determine if any corrective measures or reinforcement would be beneficial.

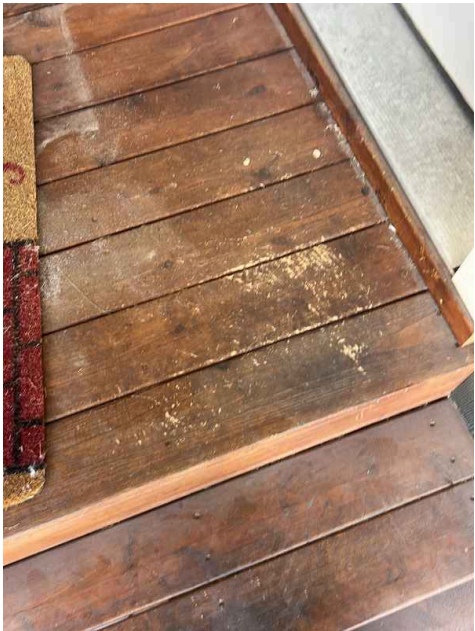
8.6.2 Porches, Decks & Balconies

RESEAL WOOD

Why it matters: Exposed or damaged wood surfaces can be vulnerable to moisture intrusion, weathering, and deterioration if not properly sealed.

Recommendation: Reseal the affected area to help protect the wood and maintain appearance.

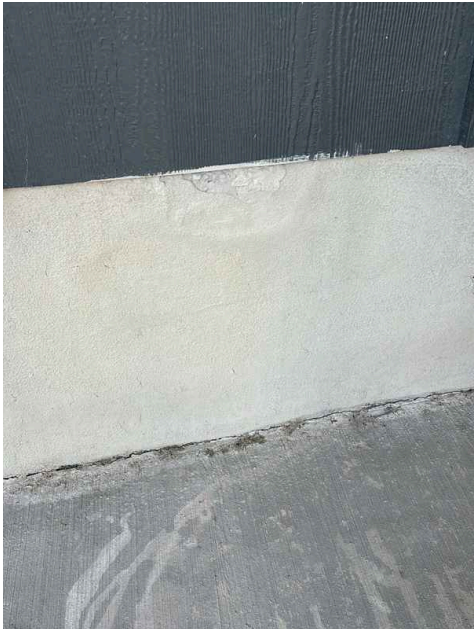
8.9.1 Wall-Covering, Flashing & Trim

**DETERIORATED PARGING**

Contact a qualified concrete contractor.

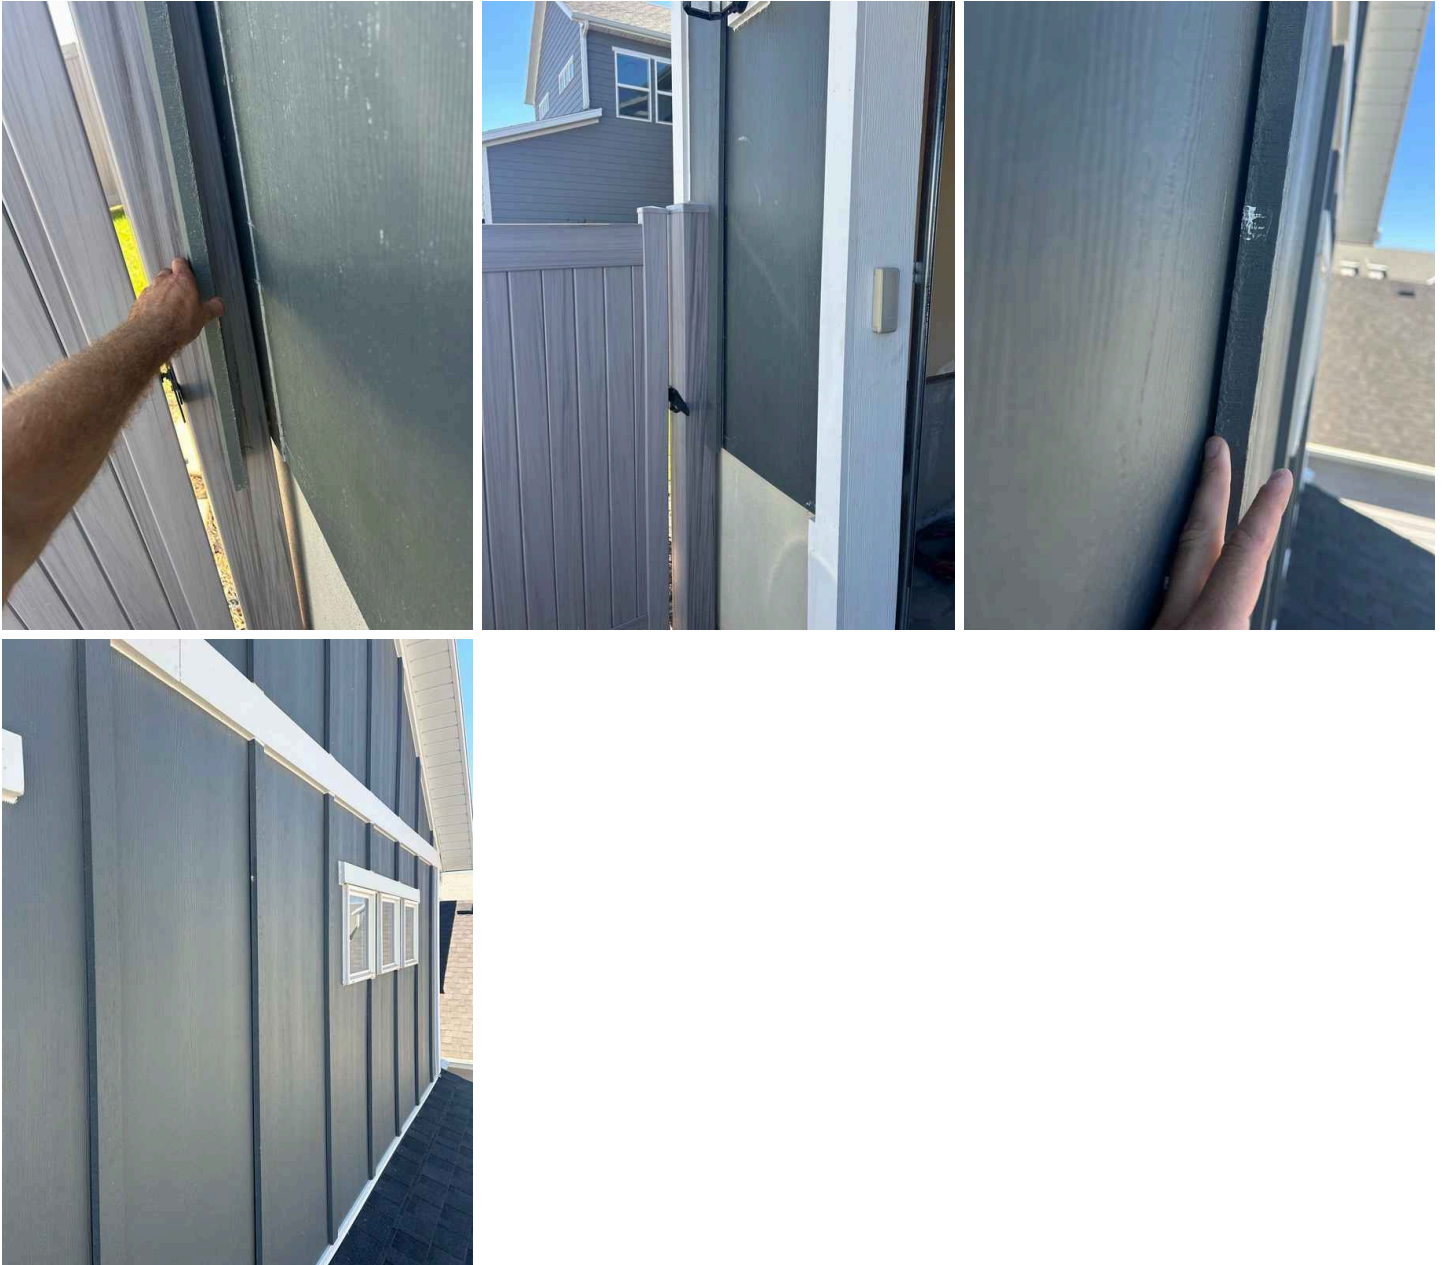
8.9.2 Wall-Covering, Flashing & Trim

**LOOSE TRIM**

Contact a handyman or DIY project
