IRON BUCK INSPECTIONS

## RESIDENTIAL HOME INSPECTION

123 N 456 W  
Layton, UT 84041

John Doe  
08/19/2025

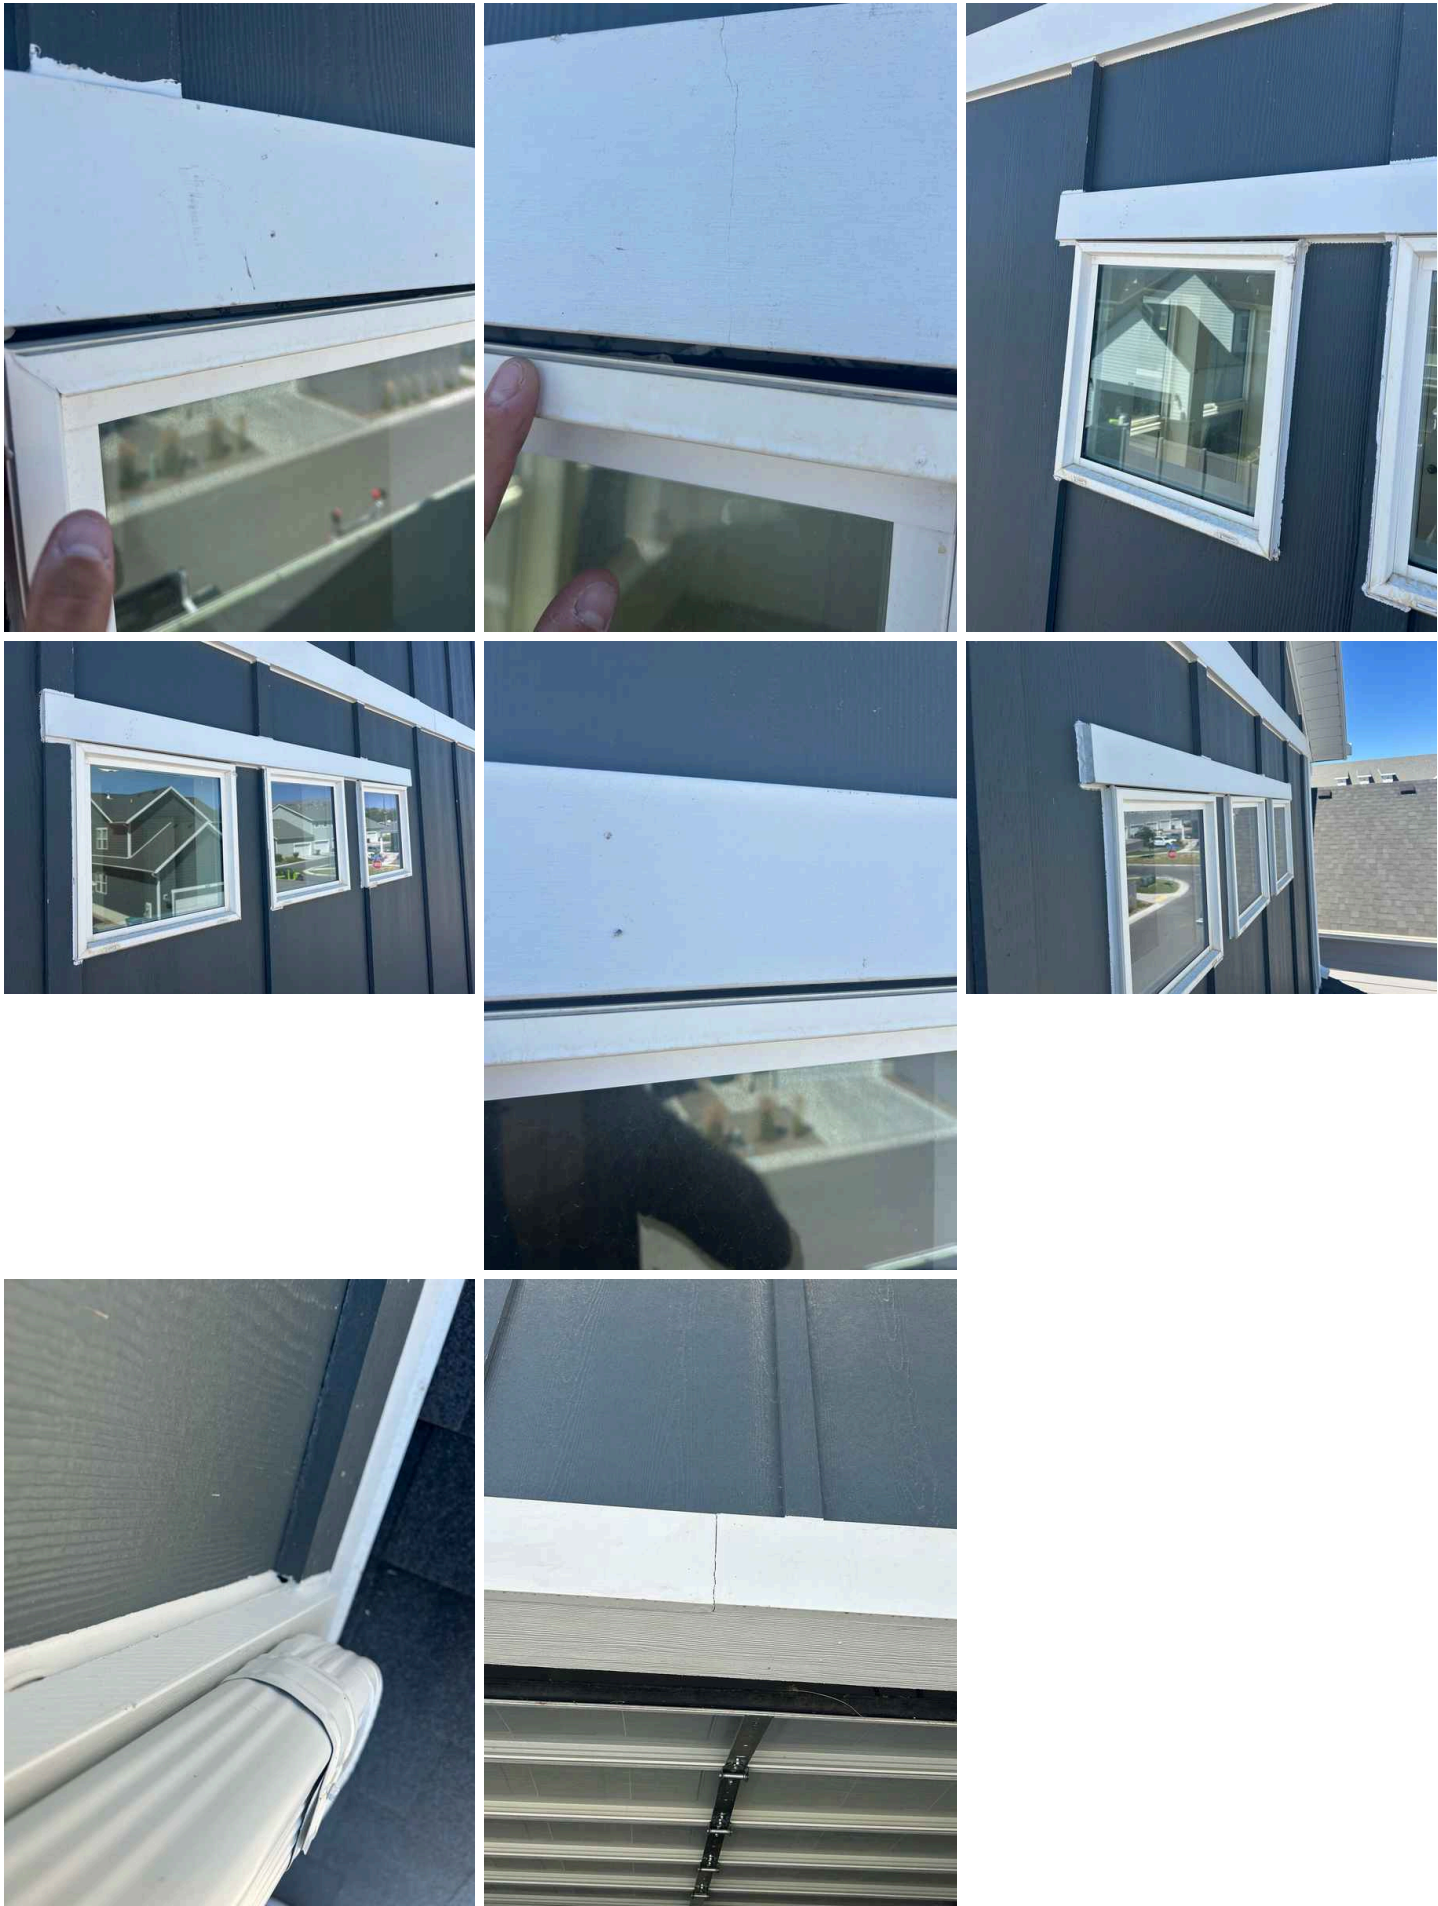
### 8.9.3 Wall-Covering, Flashing & Trim

#### **CAULKING RECOMMENDED**

Contact a handyman or DIY project

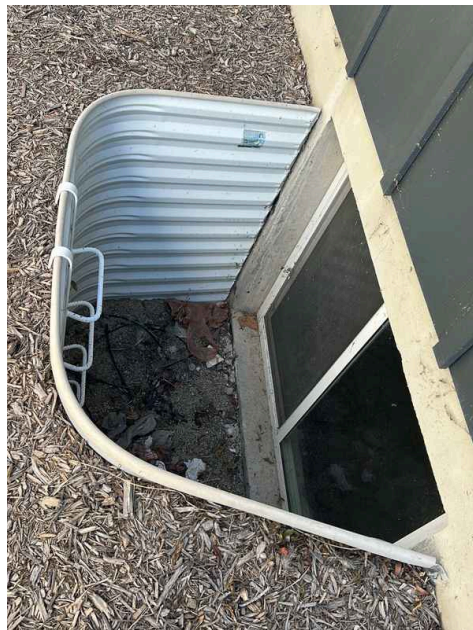
#### 8.11.1 Windows

### MISSING WINDOW WELL COVER

Contact a qualified window repair/installation contractor.

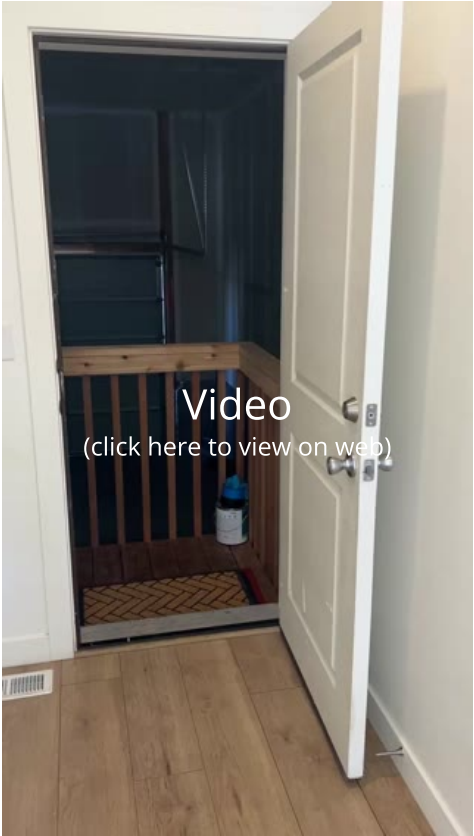
**DOOR WAS NOT SELF-CLOSING**  
Observation: The door between the garage and the house was not equipped with a self-closing or automatic-closing device.  
Why it matters: While not currently required in Utah, a door without a self-closing or automatic-closing device can increase the risk of fire spreading between the garage and living areas. A self-closing mechanism helps contain potential fires to the garage and prevent the spread of smoke and flames to the interior.  
Recommendation: Consider installing a self-closing or automatic-closing device on this door. This is a relatively easy and inexpensive repair that could significantly enhance fire safety.  
Recommendation  
Contact a handyman or DIY project

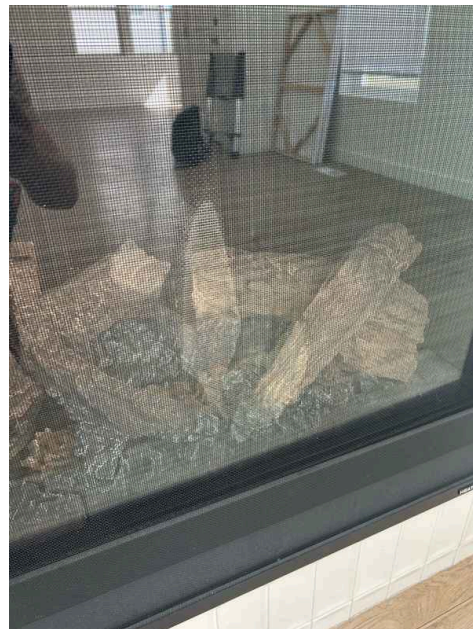
Why it matters: Discoloration can result from heat exposure or normal use but may also indicate improper combustion or overheating if excessive.

Recommendation: Monitor the condition and have the fireplace serviced by a qualified technician if discoloration worsens or if there are any concerns with operation.

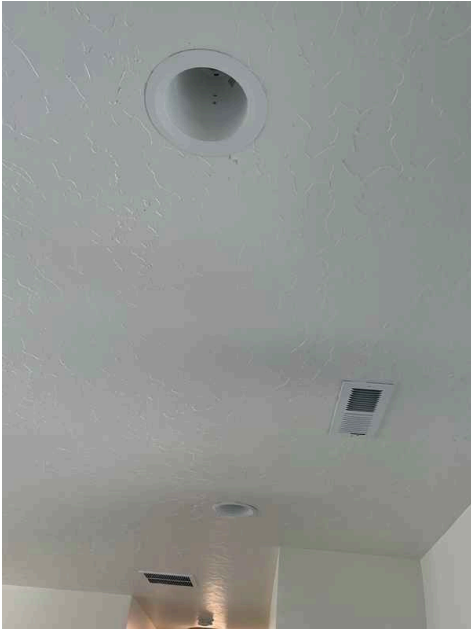
Observation: One or more light fixtures are missing bulbs, leaving empty sockets exposed.

Why It Matters: Aside from the inconvenience of a nonfunctioning light, empty light sockets pose an electrical shock hazard since the energized contact point is accessible to touch or accidental contact. Additionally, open sockets can collect dust and debris which could create a fire hazard when a bulb is eventually installed.

Recommendation: Install appropriate bulbs in all empty sockets. If the fixture is not intended for current use, install covered dummy bulbs to protect the socket and prevent accidental contact with live electrical components.

Recommendation  
Recommended DIY Project

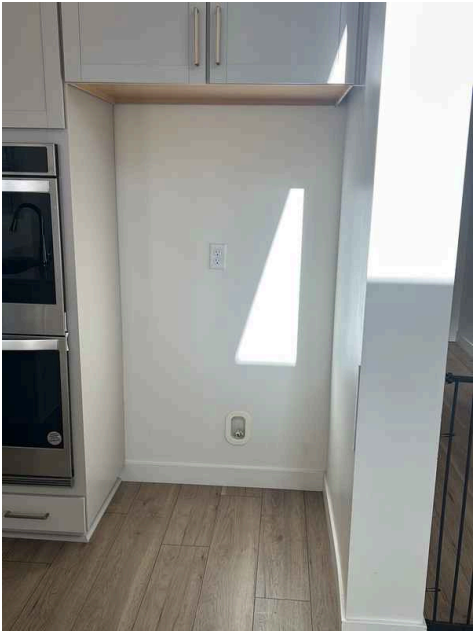
**NOT INSTALLED**

There was no refrigerator installed at the time of inspection

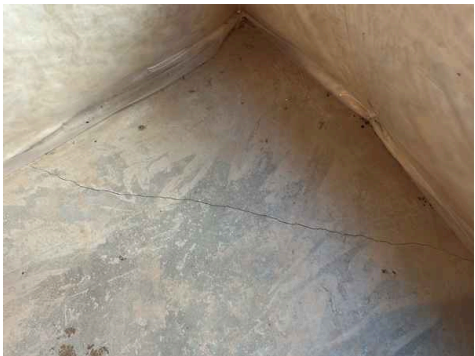
CONCRETE SLAB SHIFTING/CRACKING

Observation: Concrete slab was found to be shifting and/or cracking at the floor structure.

Why It Matters: Shifting or cracking of the concrete slab can be caused by moisture intrusion or soil movement, both of which are common issues.

Recommendation: I recommend monitoring the condition of the slab and consulting with a foundation specialist if any further movement or cracking occurs. Regular checks will help identify if repairs or further action are needed in the future.

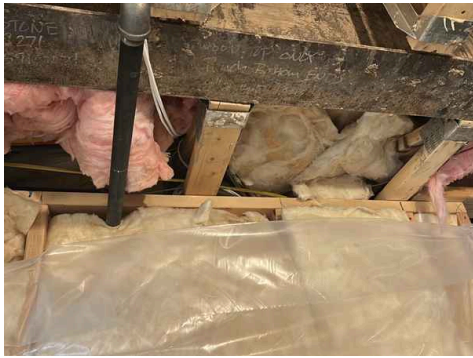
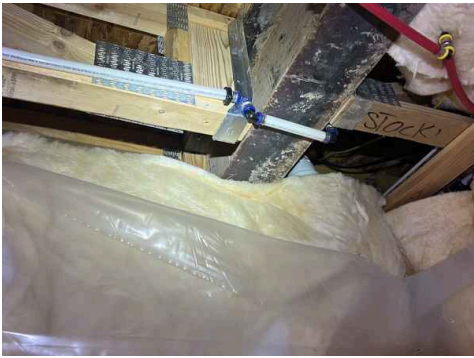
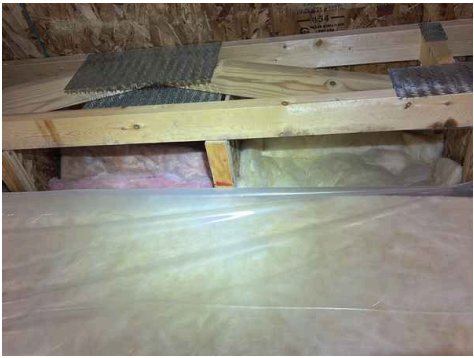
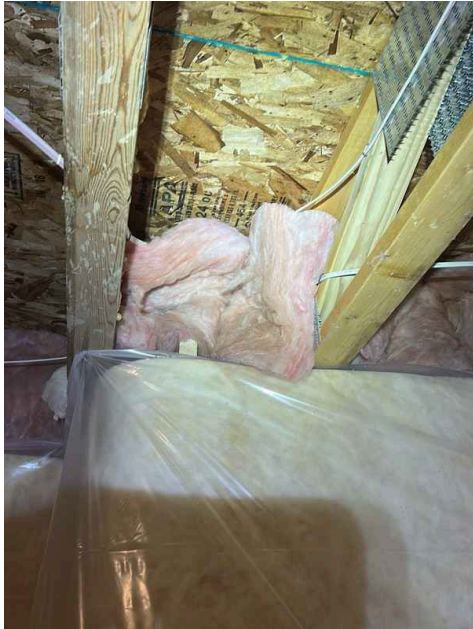
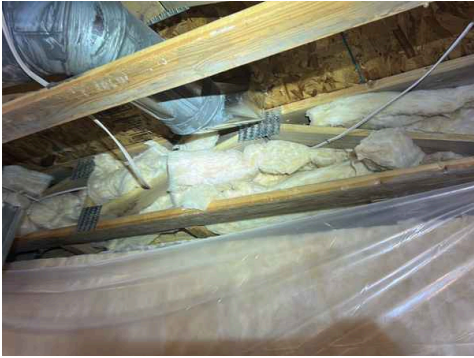
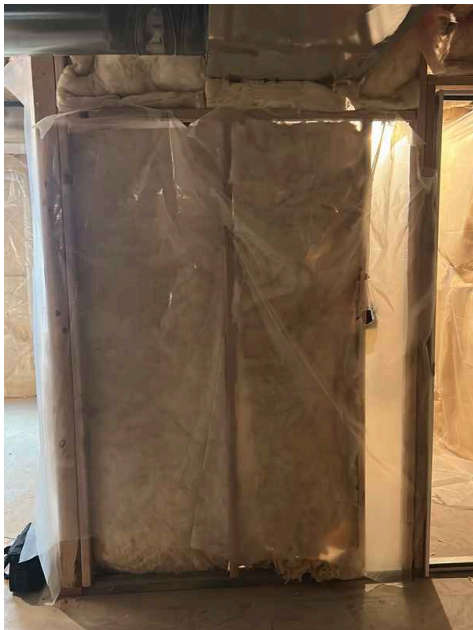
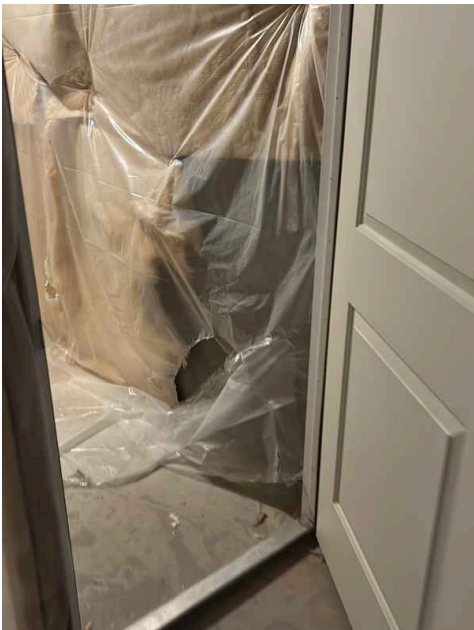
INSULATION MAINTENANCE

Observation: There were multiple insulation deficiencies in the basement. Insulation was missing in areas, had gaps and compression, and was installed haphazardly around the rim joist and within the mechanical closet. A plastic vapor barrier had been installed directly over insulation at the foundation walls, which can trap moisture. The mechanical closet was also not fully sealed.

Why it matters: Poorly installed or missing insulation reduces energy efficiency and comfort, increases utility costs, and can allow moisture accumulation that contributes to deterioration or microbial growth. A plastic barrier against the foundation can trap moisture and cause damage over time. Gaps at the mechanical closet reduce the effectiveness of conditioned air control.

Recommendation: Have a qualified insulation or weatherization contractor correct the deficiencies, remove or modify the plastic barrier to allow the foundation to breathe, and properly insulate and seal the mechanical closet and rim joist areas.

Recommendation  
Contact a qualified insulation contractor.
